Manhole Inspection Summary

Manhole # S37GG_009MH

Insp Date: **3/21/07 9:06 AM**

Location Address: **415 OLIVER ST**

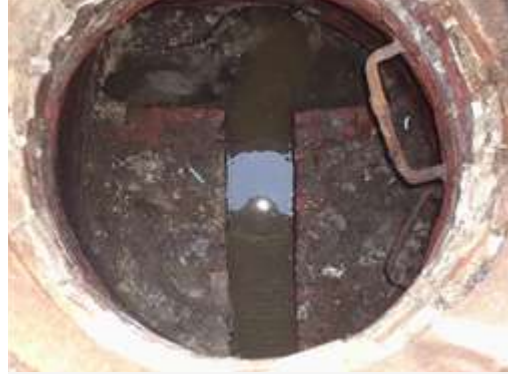
Top View

Corroded steps. Evidence of surcharge - Bench debris. Channel debris.

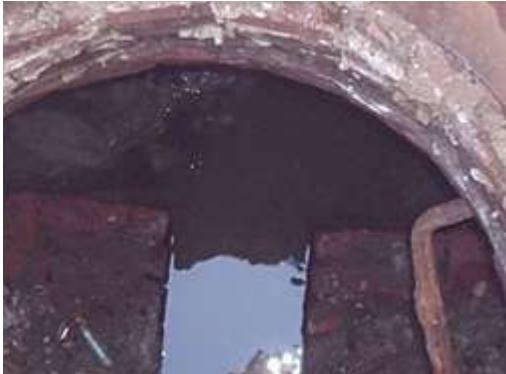
Defect

Frame leaks. Frame offset. Adjustment deterioration and infiltration.

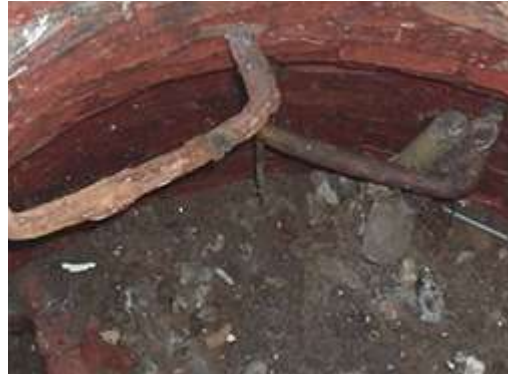
Defect

Barrel infiltration. Corroded steps. Evidence of surcharge - Bench debris.

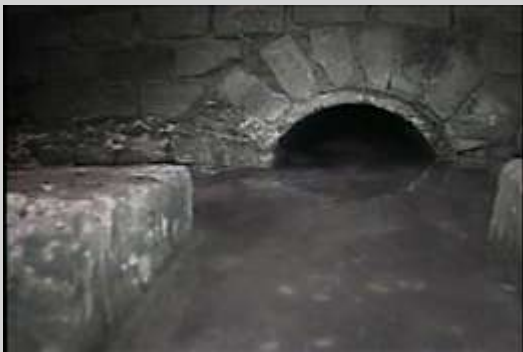
10 in. Circular Gravity Sewer Pipe Out @ 12 O'Clock

Infiltration: **Evidence** Pipe Seal Cond: **Unknown**

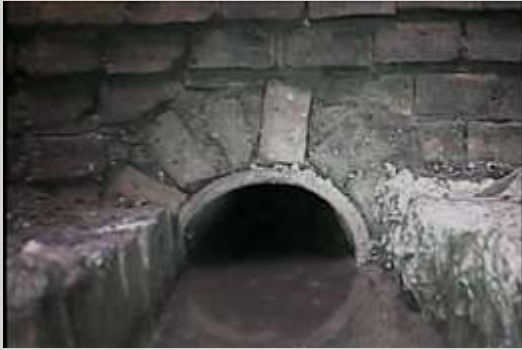
Pipe In @ 6 O'Clock

Deposits: ☐ None ☒ **Mud** ☐ Sludge ☒ **Debris** ☐ Grease

Silt Depth: **1** (in.) Deposits Extent: **Light**

Infiltration: **Evidence** Pipe Seal Cond: **Broken**
